Corrosion

OFFICIAL MAGAZINE OF THE CORROSION INSTITUTE OF SOUTHERN AFRICA

Corrosion management of elevated lattice galvanized structures – *Care for the aged* (Part 2)

Battling building envelope corrosion

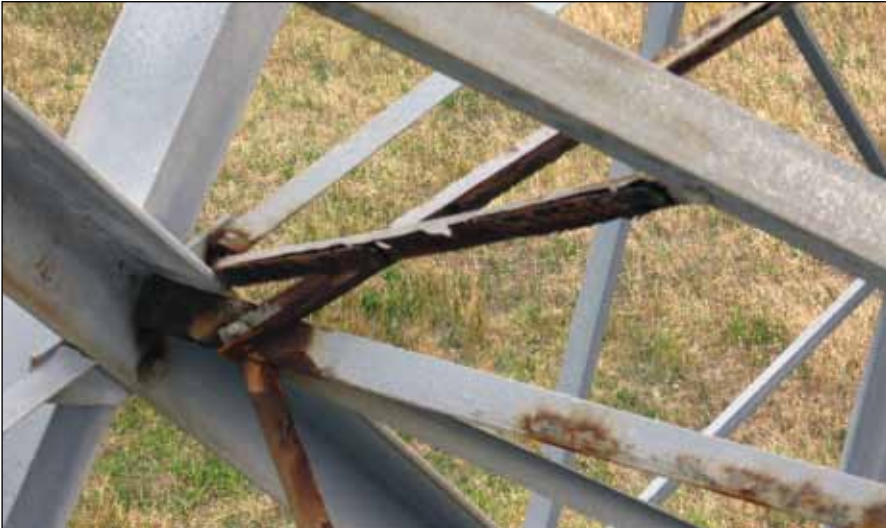
This print shows a good example of how the lighter members, which start with an initially lower thickness of galvanizing, corrode way earlier than heavier members like the main legs. The orientation of the sections also changes the amount and rate of zinc loss. These lighter members are due to be replaced, as attempting to economically and reliably clean and paint these in situ will be futile. The legs members, however, are in a near perfect condition to be cleaned and painted whilst some galvanic capability remains.

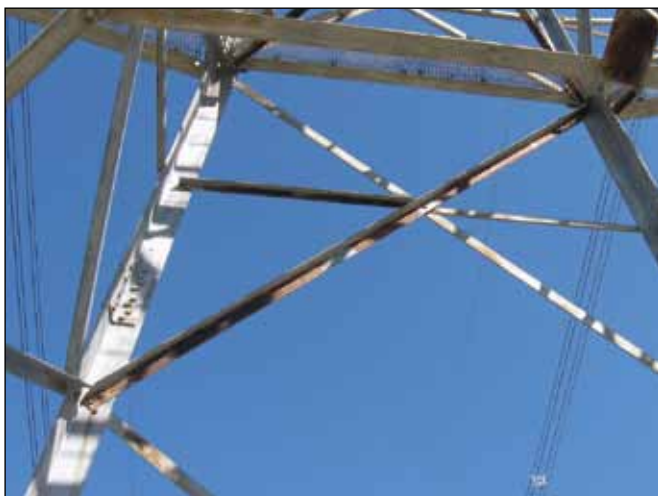
This shows quite dramatically how lighter members and those that have sheltered surfaces not subject to fresh water rain washing, lose zinc thickness and corrode way quicker than heavier and near-vertical members. Replacement of the face braces is not yet due but is relatively easy when required as only a few bolts need to be removed to change out these simple steel sections.

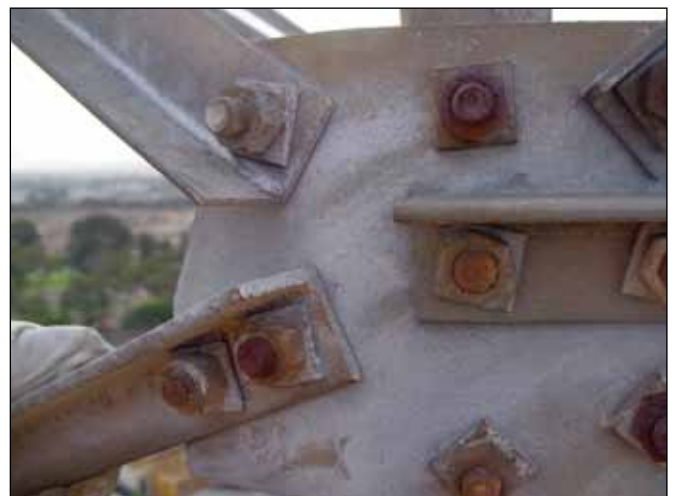
One of the first signs of the loss of galvanic capability is the commencement of gingering of bolts and fasteners. This is partly due to the lower initial thickness of the galvanizing, as such items are usually centrifuged just after withdrawal from the galvanizing kettle. Note the comparative degree of condition of the cleat plate and the affixed angle members versus the bolts.

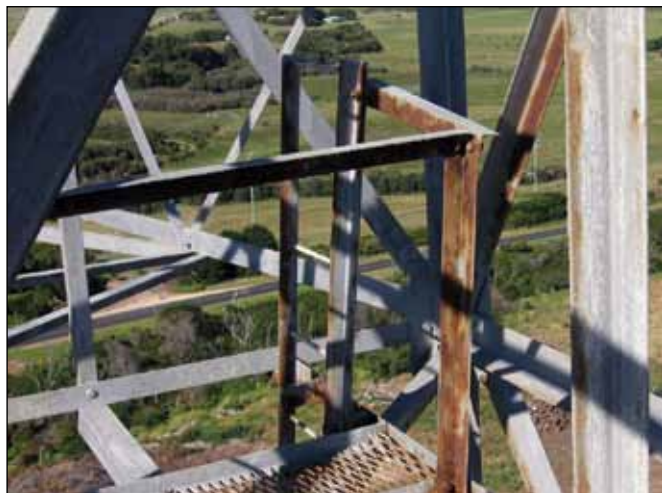
These landing handrails are currently still functional but will progressively lose section thickness and integrity. Therefore, they are not worth spending any time and money on before they are corroded enough to require replacement. However, the main leg members and the compression struts for the cross arms in the background should be cleaned and repainted shortly before their condition deteriorates to the point that the surface preparation intensity rises too far.

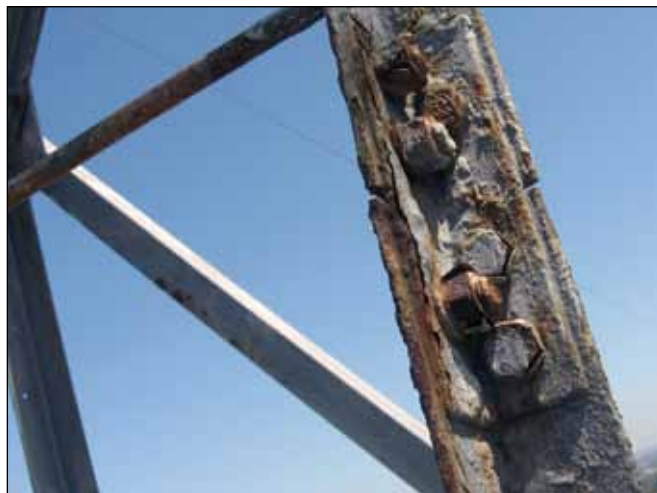
A splice joint in a ladder run is shown, demonstrating how lighter members and where pockets and unsealed connections are more vulnerable. The tower is about 35 years old and was painted with epoxy high build about 13 years ago. Rather than attempt to site clean, prepare and paint these surfaces, it would be better to remove, blast and regalvanise the ladder, make new splice plates and fit these together with new bolts.

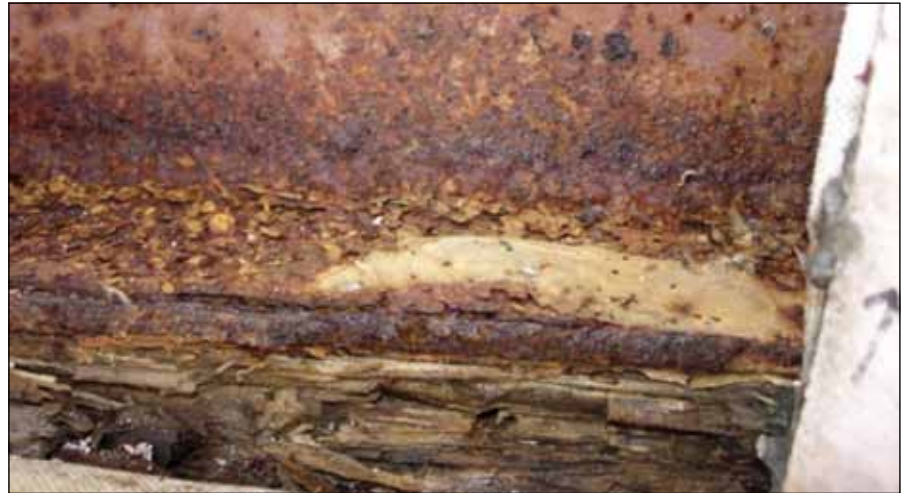
Rusting steel has exposed structural timber which has begun to rot.

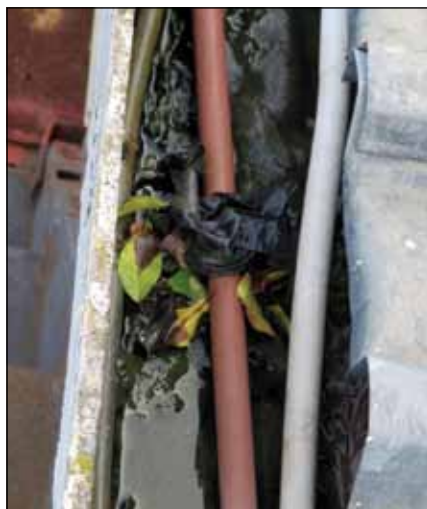
Rain water gutters must be frequently cleaned of all debris and other service pipes should not be laid within them, in order to maintain their integrity.

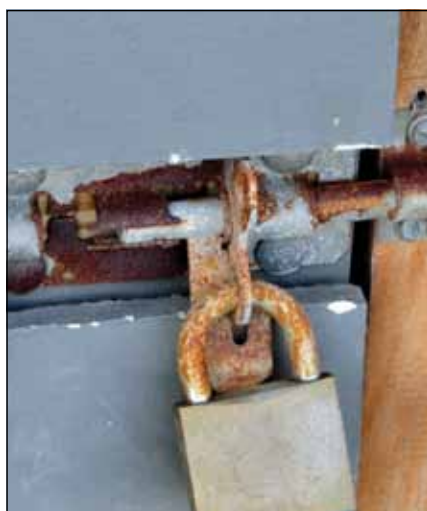
Making use of an inappropriately coated door latch and lock in an aggressive marine environment, will generally result in premature replacement.

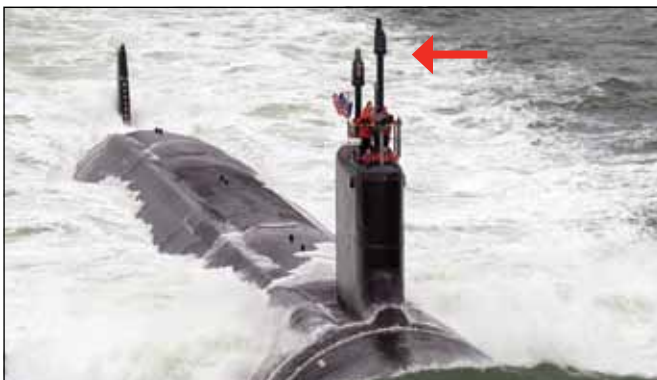
Submarine at sea – the arrow shows the antenna we investigated.

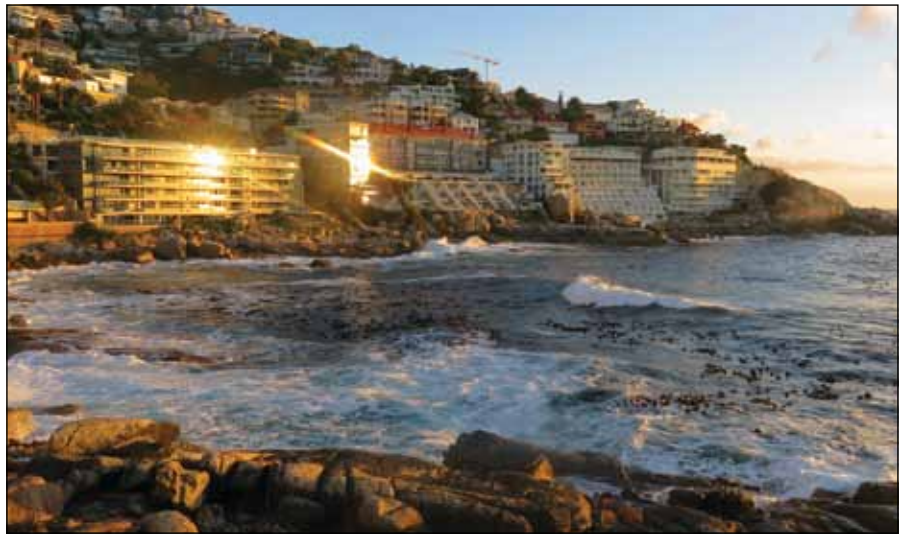
Concrete corrosion can occur rapidly on buildings subjected to marine environments.

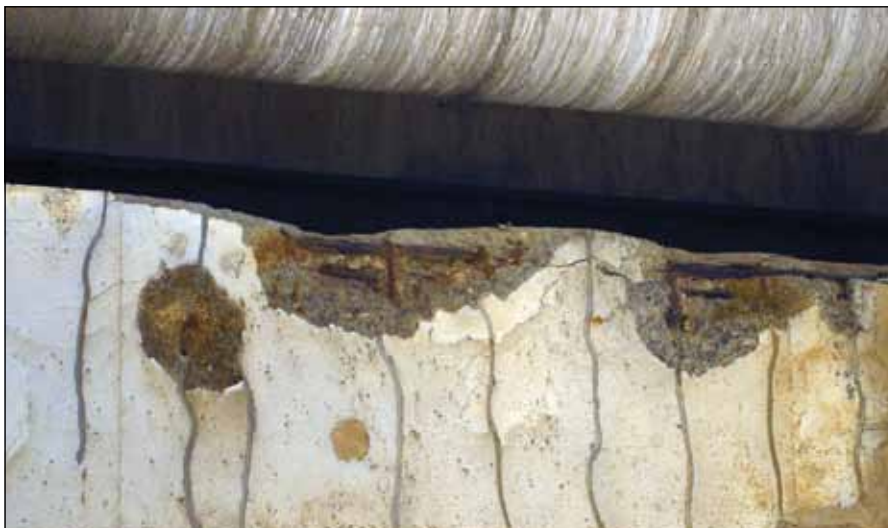
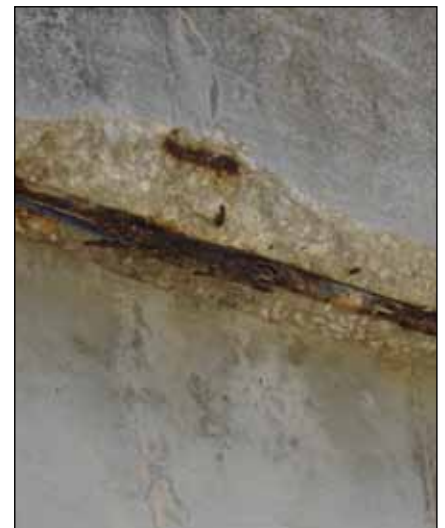
Surface discoloration and cracking of the concrete will ultimately lead to concrete spalling and potential failure.

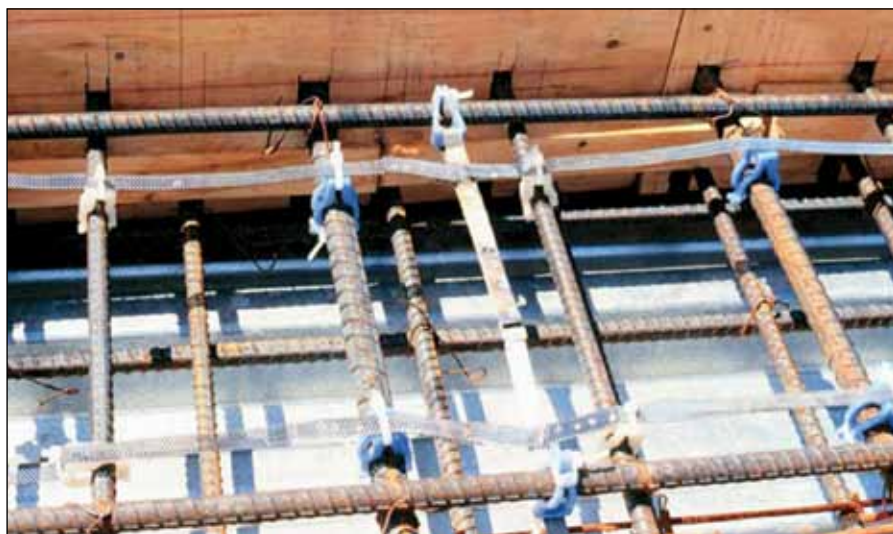
Where de-icing salts have led to the corrosion of the upper reinforcement in this bridge deck, a grid of mixed metal oxide (MMO) coated anode strips have been installed. These will be fully encapsulated with a dense concrete over layer.

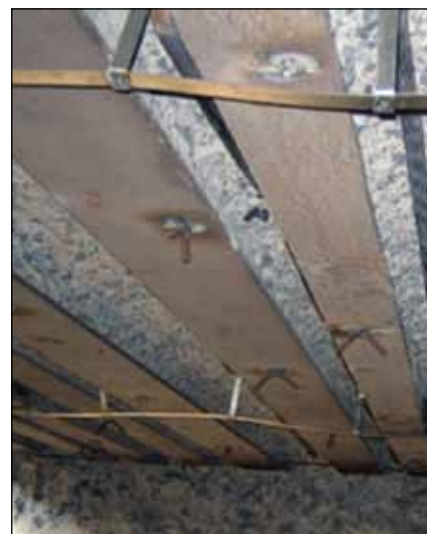
Underslab grid of mixed metal oxide (MMO) coated anode strips installed to significantly retard the corrosion of the underside in situ reinforcement of this concrete slab.

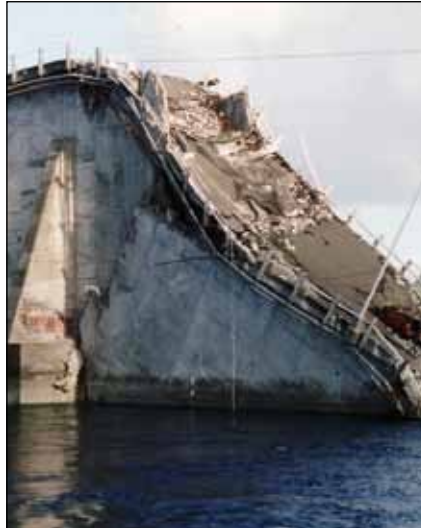
Bridge collapse due to corrosion of steel in concrete.

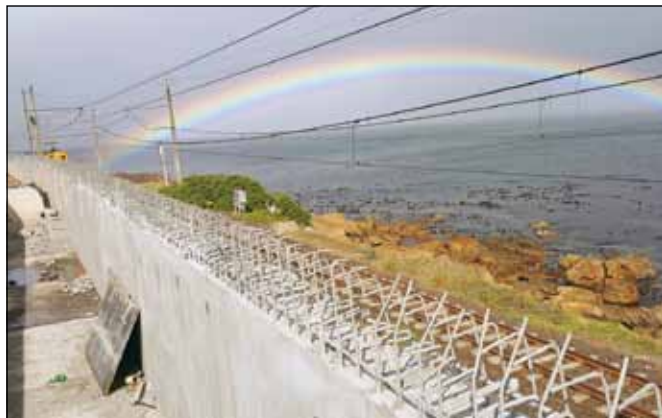
View with a rainbow and a train approaching of the hot dip galvanized high yield starter steel bars for the crash impact designed coping barrier of the Clovelly (Cape Town), retaining wall.

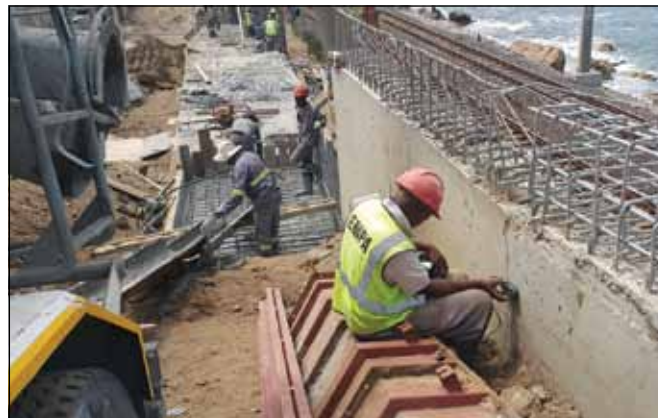
A cover meter was used to check the concrete cover over the hot dip galvanized high yield reinforcing steel, before assembling the steel coping shutters.

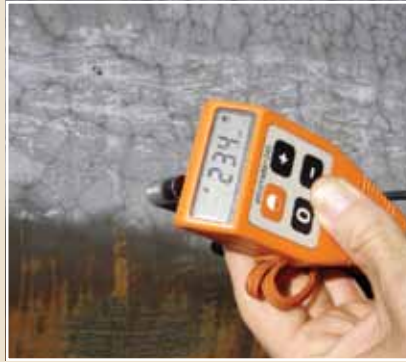
Coating thickness of 103µm on the matt grey portion.

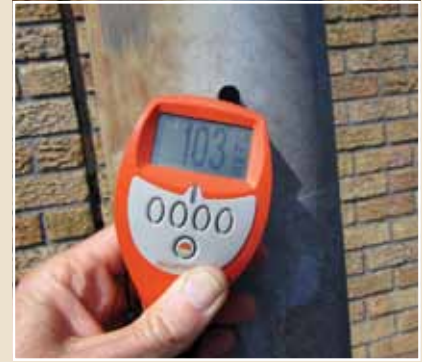
Coating thickness of 180µm on the Fe/Zn discolored portion.

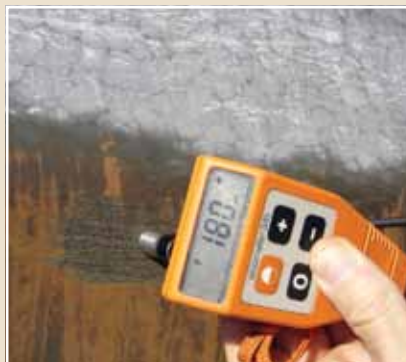
Coating thickness of 83.7µm on the Fe/Zn discolored portion.
